LEAD BASED PAINT BUILDING SURVEY REPORT

Former Rainier Brewery 3100 Airport Way Seattle, Washington 98134

November 20, 2006

VEI Project #061013 LBP Survey

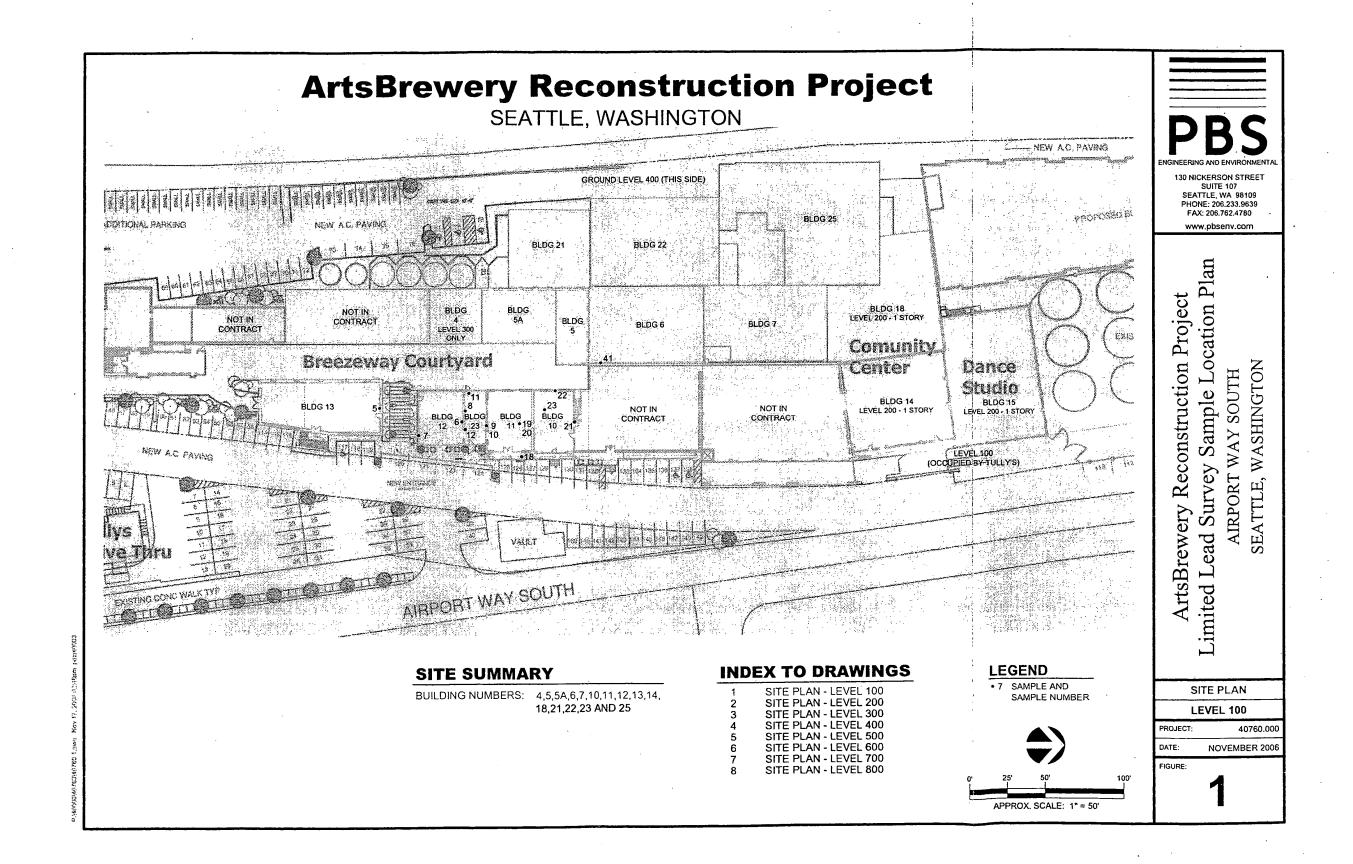
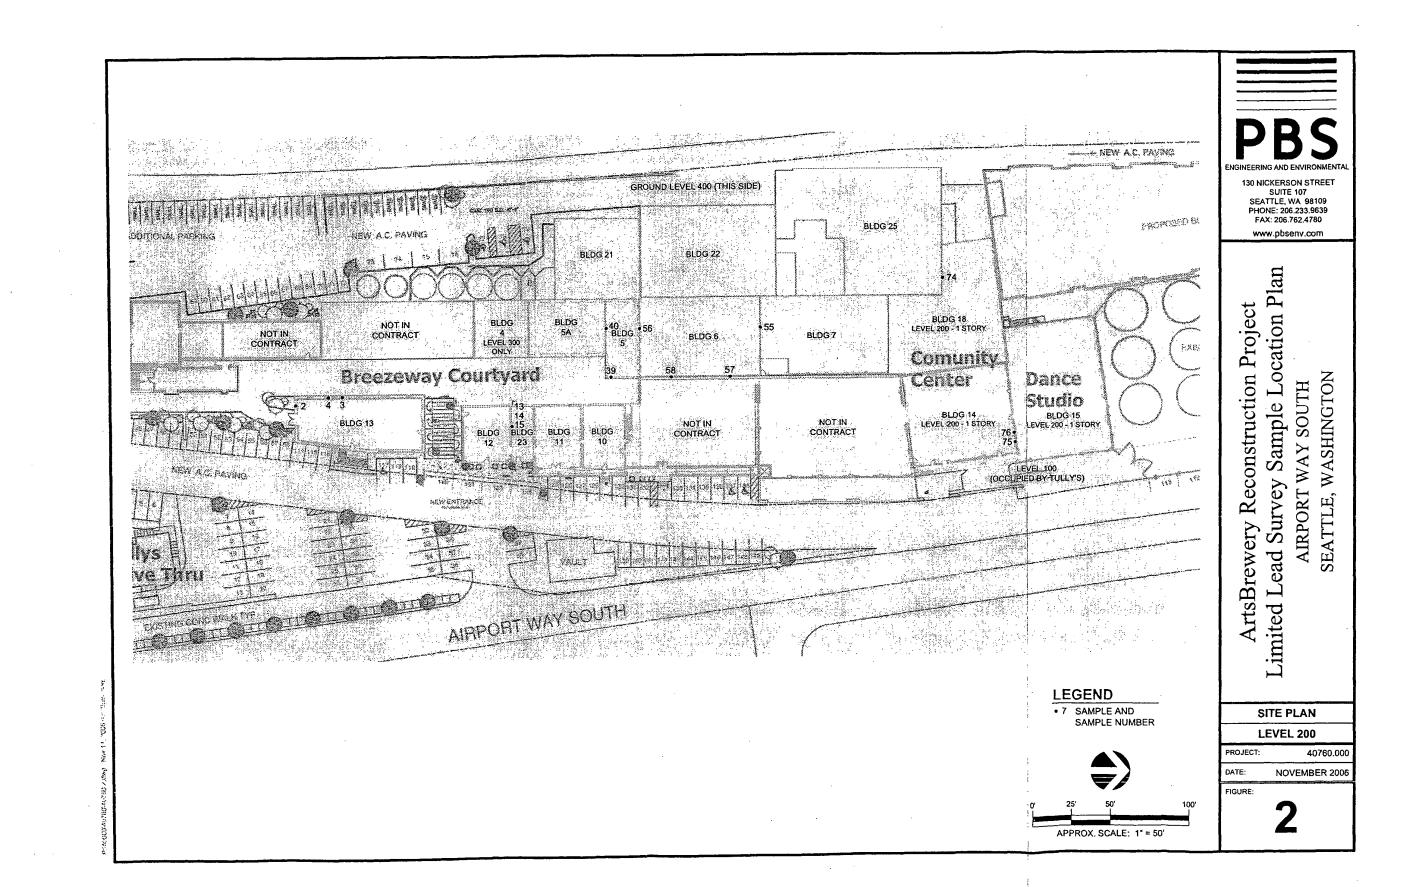
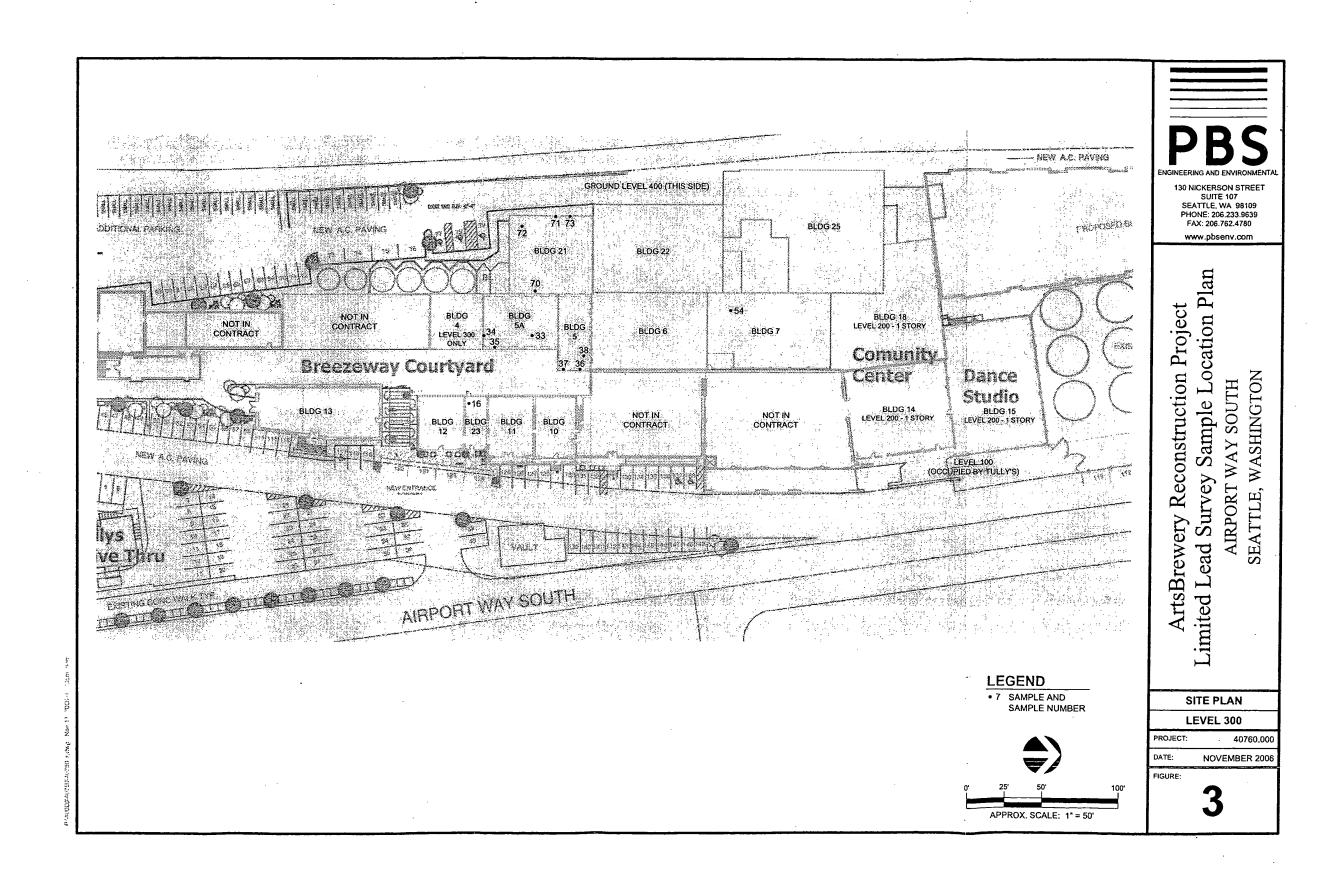
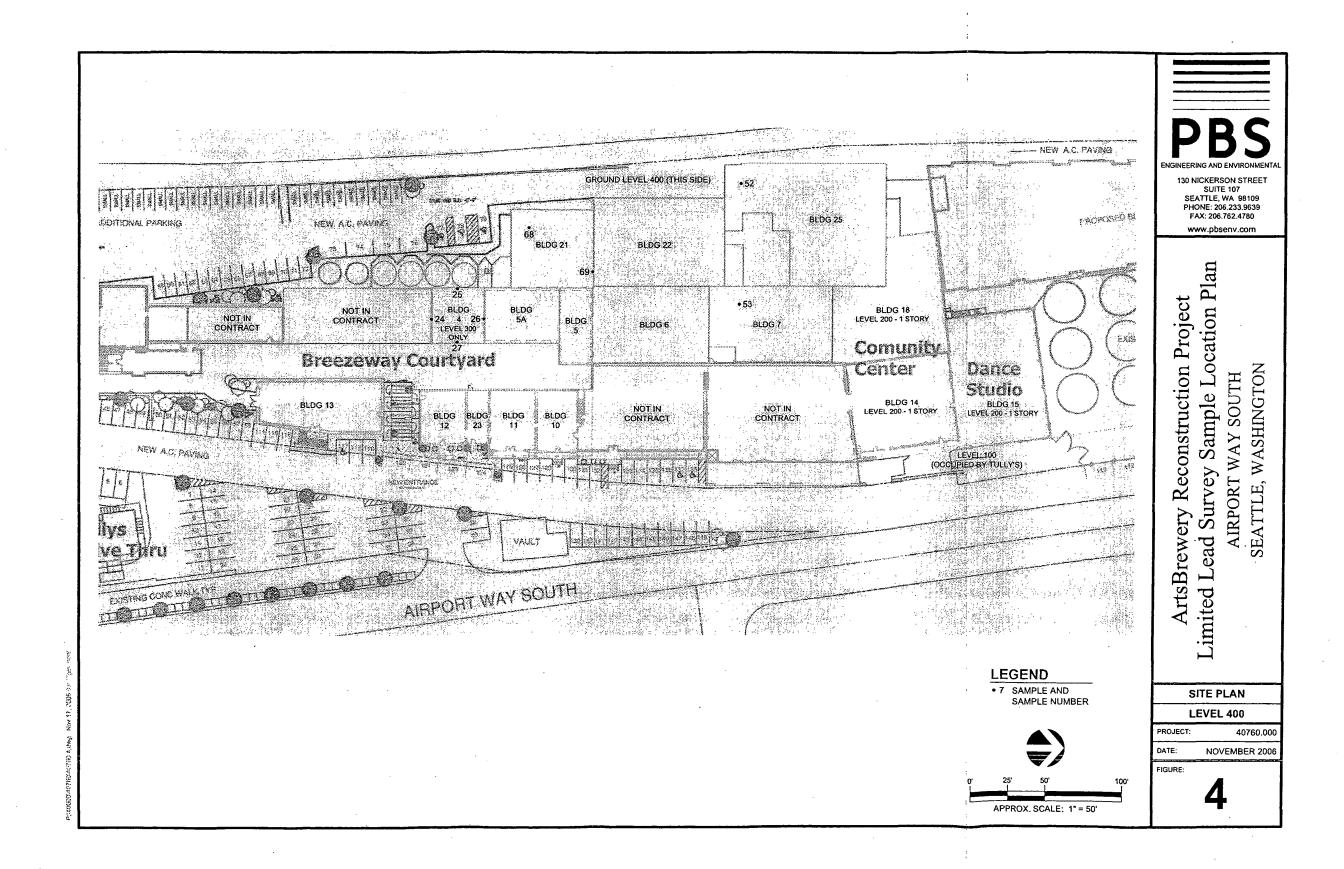
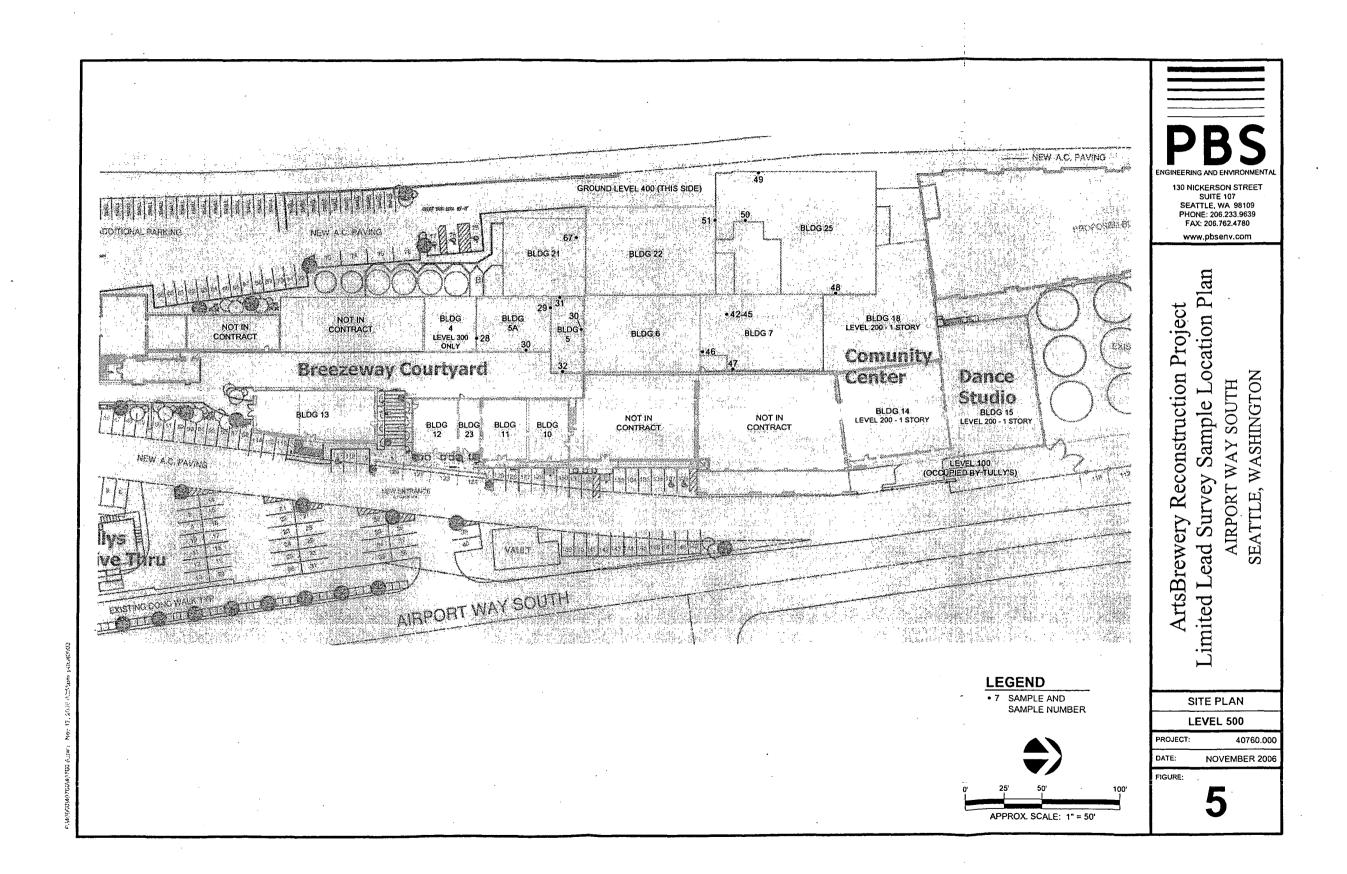
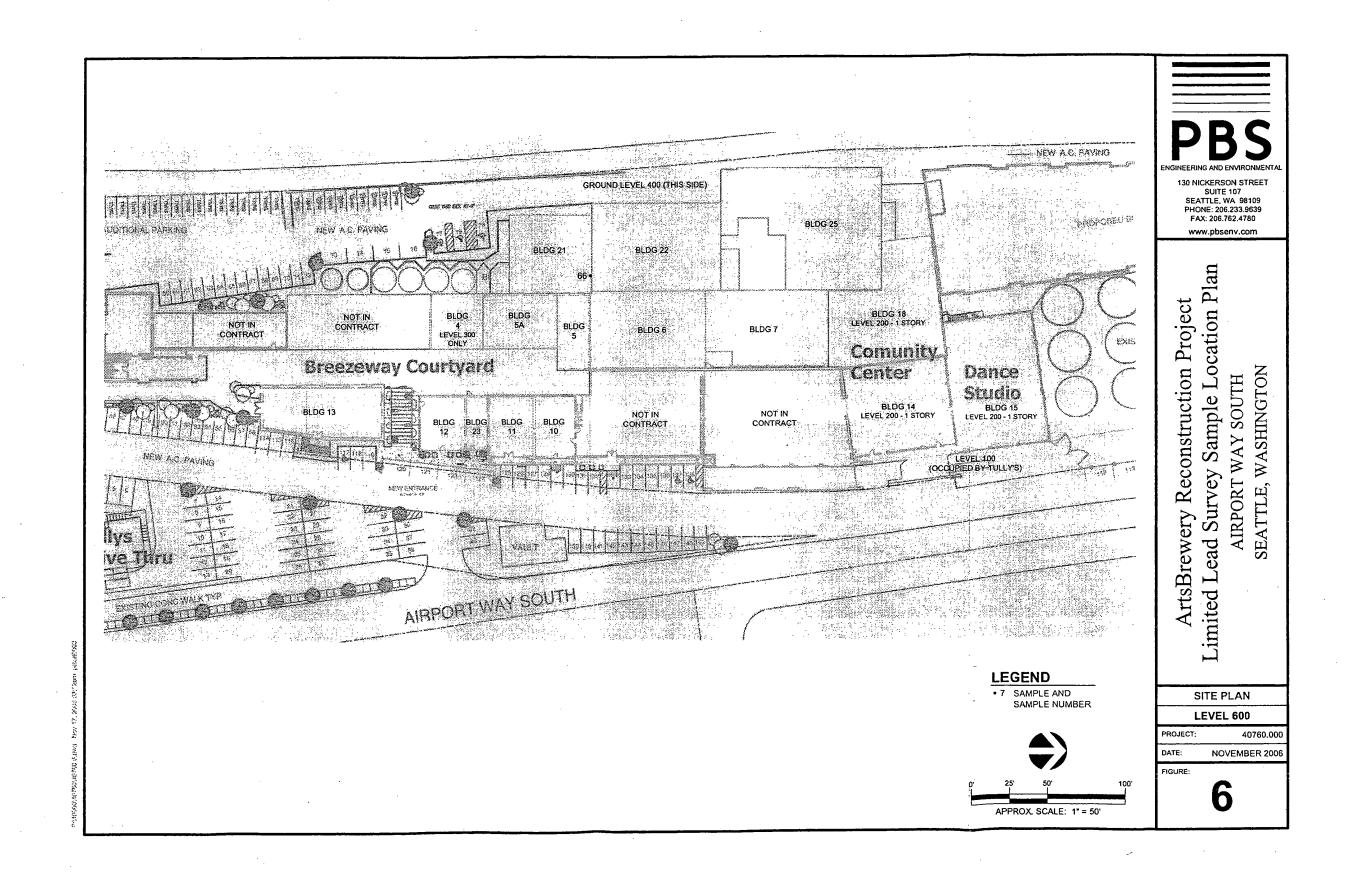
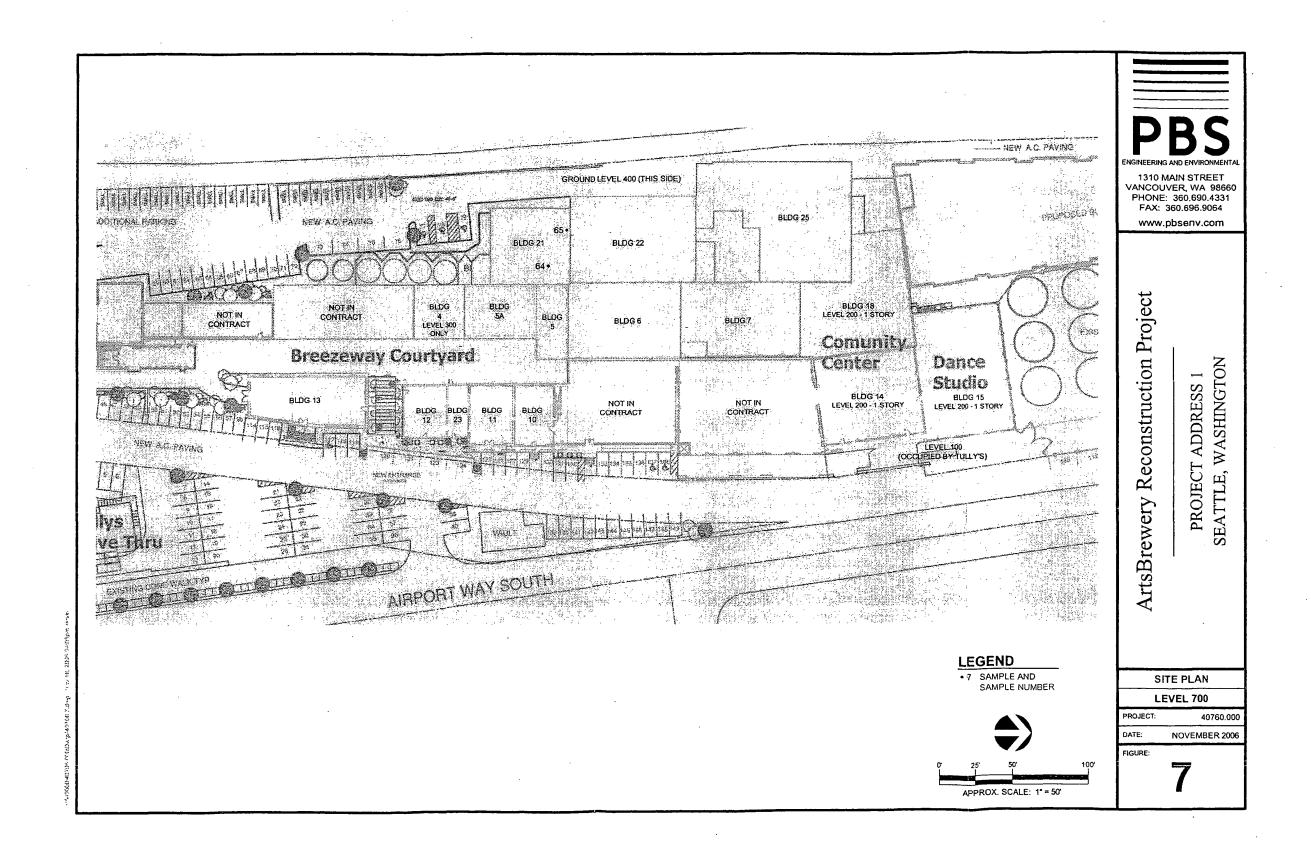
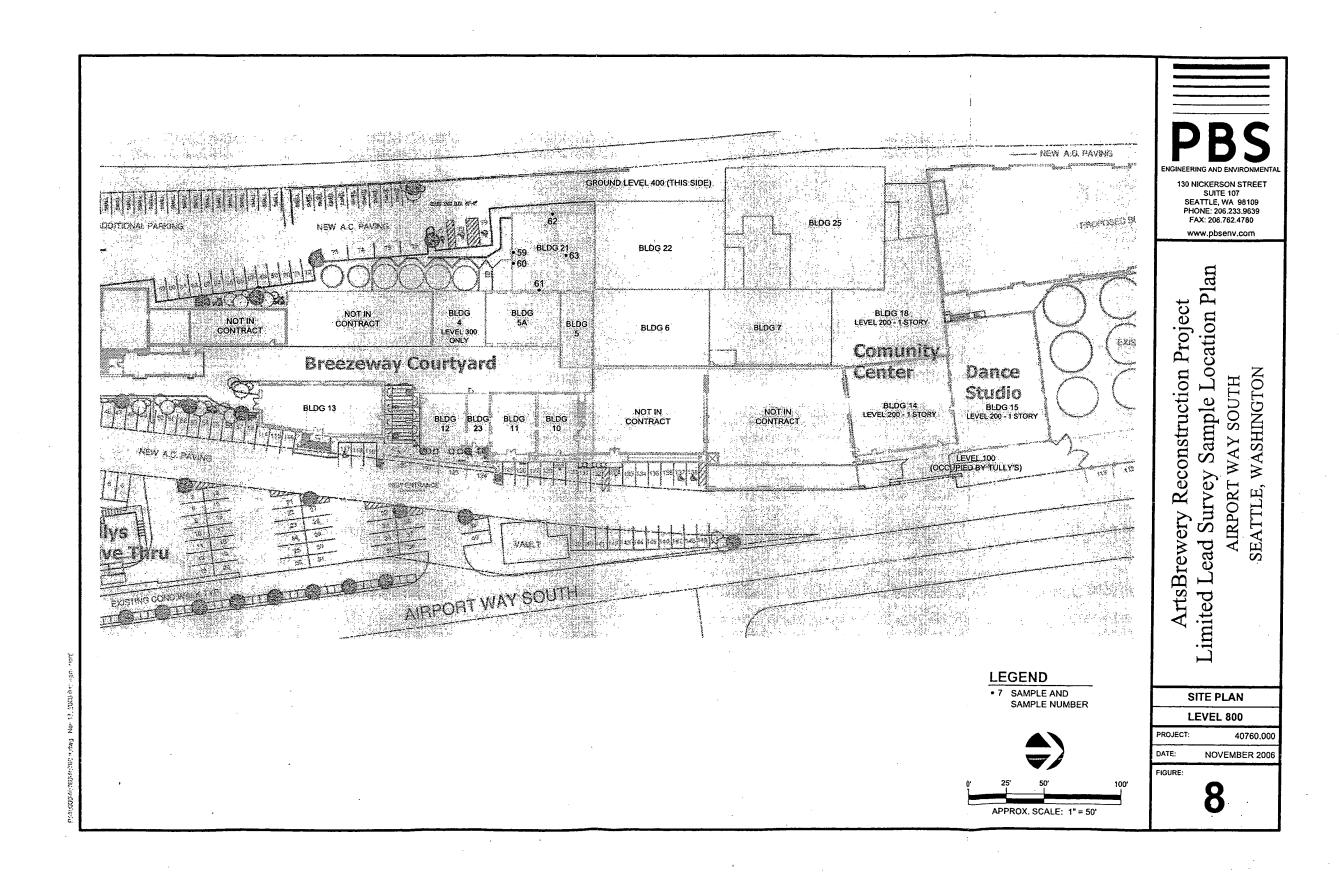
APPENDIX B SITE PLAN DRAWINGS

The following is a presentation of building information and XRF sampling results. Sample locations, XRF data sheets and bulk sample data are located in separate tab sections of the report.
